FOX OAKLAND THEATER BUILDING

Historic Resource Evaluation

**The City of Oakland
Community and Economic Development Agency**

January 24, 2001

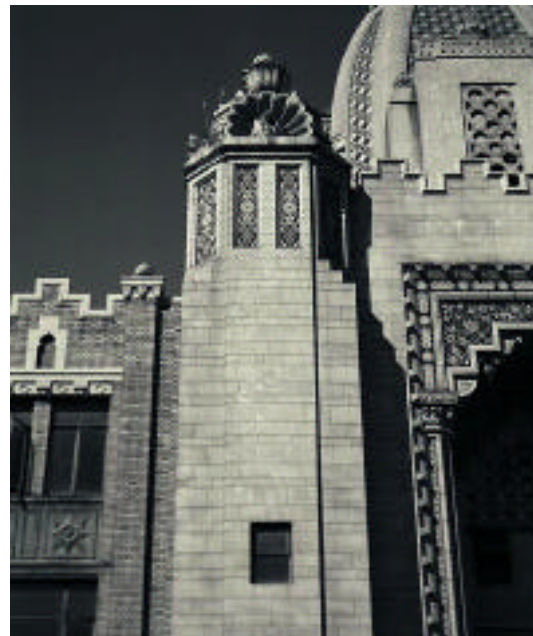
Figure 7: South Pylon

The cast concrete portions of the façade are in sound condition, exhibiting some peeling paint, but otherwise intact. The inset tile panels in the tower are dirty, but generally intact. All of the terra cotta ornament at the top of the pylons is in very good condition with the exception of some accumulation of soil over the south pylon that has allowed for some plant growth. The terra cotta cladding on the face of the building exhibits extensive spalling. This condition is considerably worse on the face of the pylons, indicating some possible moisture intrusion at the terra cotta caps. The terra cotta ornament and tile surrounding the central recess appear to be in good condition, but were not examined at close range. The sign and marquee are considerably deteriorated, but are currently scheduled to undergo extensive restoration.

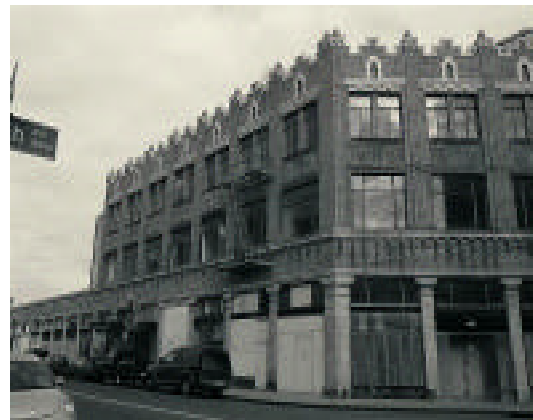
Figure 8: South office wing

The terra cotta ornament at the parapet level is in very good condition with some staining evident at the top edge, while the terra cotta sill below the second story windows is heavily stained. The staining in this case appears to be ferrous in nature and is probably caused by run off from the metal windows and spandrels above. The brick is in generally good condition, but does exhibit staining at a number of locations. There is some staining just below the parapet, moderate on the south façade and more severe on the north façade. Staining is evident along side the metal windows and spandrels, again probably ferrous stains from the adjacent metal windows and spandrel panel. Below the second floor windowsill, the brick is heavily stained, a continuation of the stains on the terra cotta. There is severe deterioration of the paint at the metal windows and spandrel panels, and extensive corrosion has resulted. The marble at the base of the pilasters is cracked or missing in a number of locations, but where it remains intact, it is in good condition.

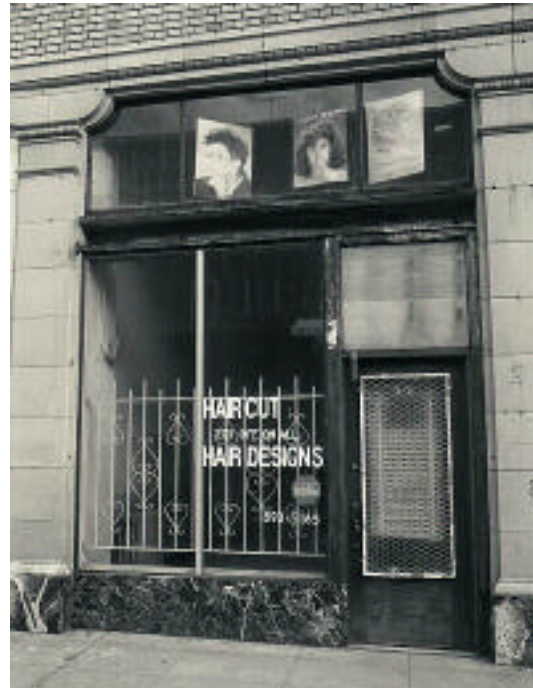
Figure 10: Typical Storefront

All of the storefronts show signs of deterioration. Most of the wood doors and trim are in fair to good condition, but some have been extensively damaged by installation of security devices and other hardware. The base is mostly intact, but has been painted over in a number of locations and has been

replaced in a few others. The original storefront glazing strips are in fairly good condition. All but a few awnings are missing, and those that remain are in only fair condition. The transom windows were not accessible during this survey, but appear to be mostly intact with the exception of several pieces of operable sash which have been altered or replaced. In general, the transom windows are in fair to good condition. The metal marquees over the office lobby entries are intact and in good condition.

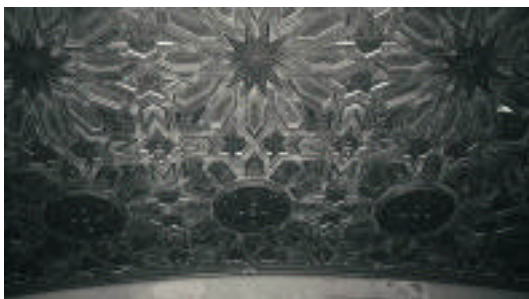
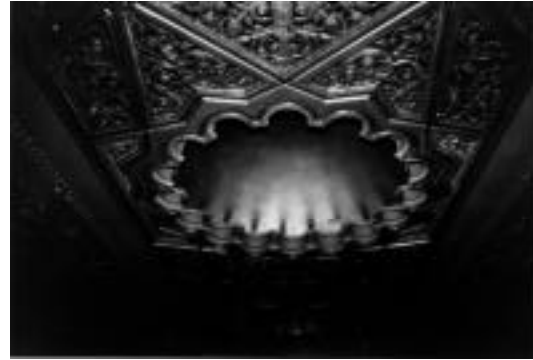
The auditorium is in good condition. The plaster walls and ceiling are largely intact. Some water damage is evident in the ceiling along both side walls, but this occurs beyond the edge of the ornamental portion above the vomitories. The seats have been removed and some stored in the basement, and the stepped floor has been partially demolished. The chandeliers are missing from the main ceiling. A number of the large light fixtures are missing from below the balcony, but at least one of each type remains. The mirrors and metal screens are missing from the niches below the balcony, and the fire hose cabinets near the rear of the auditorium are missing the hose brackets, although one of the missing brackets is currently stored on the Stage.

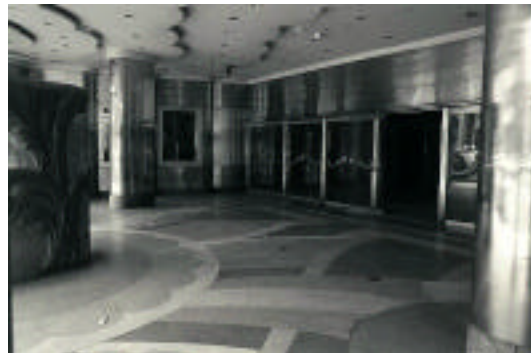
Figure 15: 1945 Vestibule extending into Original lobby area

The Lobby was entirely altered as part of the 1945 remodel of the theater entry. The outer doors were removed and new glass doors were installed in the center

of the lobby, expanding the entry vestibule. The high bay was converted into two levels of office space and all original material was removed except for the mural. According to news articles, the mural remained in place behind the new office walls until at least 1985, when it was apparently stolen. The lower walls were covered by new stainless steel panels in the expanded vestibule area and the marble in the smaller lobby was removed and relocated at a different plane. The floors were redone in terrazzo. The only original materials that survived the remodel are the wood paneled doors leading to the Foyer. The design of these doors with a single recessed cruciform wood panel is typical of the wood panel doors throughout the theater.

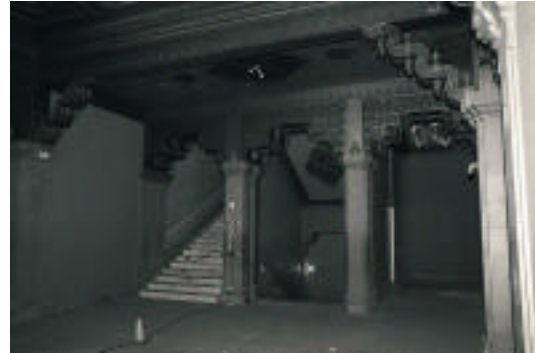
Figure 19: Mezzanine Foyer

The Mezzanine is in remarkably good condition. The only major alteration is the elimination of the openings into the former Lobby by installation of an infill plaster wall between the columns. The original carpet has been removed, as have the drinking fountains and mirrors.

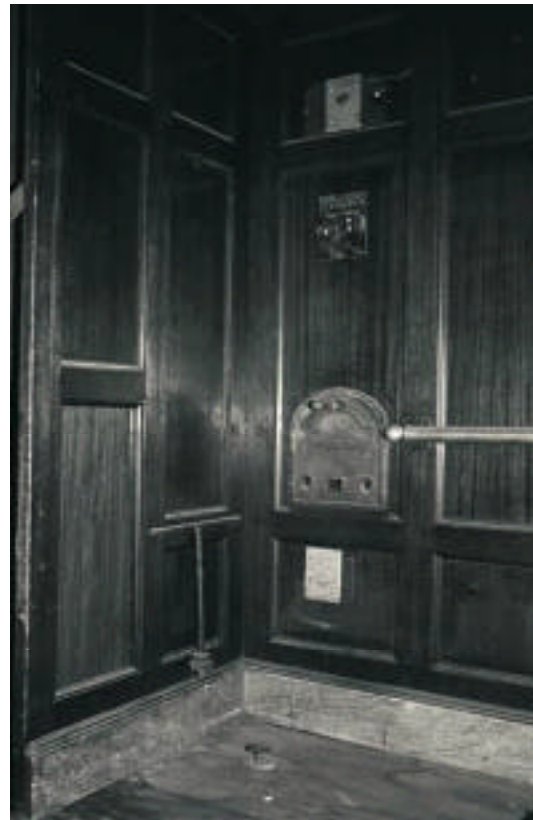
Figure 22: Elevator Interior

The elevator doors were wood sash with mirrored lights set in an imitation stone surround with cast plaster brackets. An ornamental cast plaster frieze was set above the opening. The floor of the cab was wood and may have been carpeted originally. The base was marble, and the walls and ceiling were wood paneling. A brass pipe handrail ran continuously on three walls. The elevator was attendant operated. The elevator at the north end of the foyer is intact and original, with the exception of two damaged wood panels.

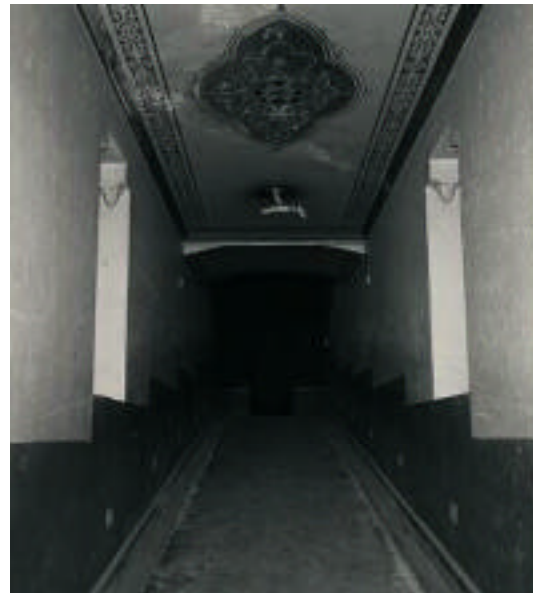
Figure 23: Center Vomitory

The vomitories are all in original condition, but the plaster surfaces have sustained some damage, especially the ceilings in the Upper and Lower Vomitories. All have suffered substantial damage due to moisture intrusion. The ceiling in the south Upper Vomitory has sustained the most damage. Enough

original stenciling remains, however, in the other vomitories to provide a model for its eventual restoration.
