FOX OAKLAND THEATER BUILDING

Historic Resource Evaluation

**The City of Oakland
Community and Economic Development Agency**

January 24, 2001

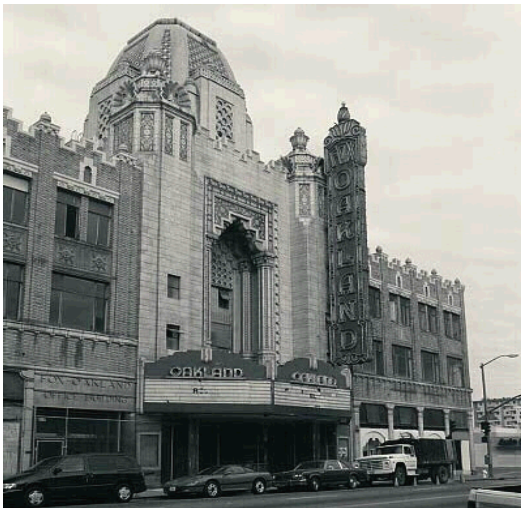
Figure 5: Theater Facade

The beacon that originally topped the tower is now missing, and the flagpoles that were located on top of each pylon are also gone. The original marquee has been replaced with a more modern art deco style marquee. Although not original, it has been in place since 1935, and should be considered a historic element.

The cast concrete portions of the façade are in sound condition, exhibiting some peeling paint, but otherwise intact. The inset tile panels in the tower are dirty, but generally intact. All of the terra cotta ornament at the top of the pylons is in very good condition with the exception of some accumulation of soil over the south pylon that has allowed for some plant growth. The terra cotta cladding on the face of the building exhibits extensive spalling. This condition is considerably worse on the face of the pylons, indicating some possible moisture intrusion at the terra cotta caps. The terra cotta ornament and tile surrounding the central recess appear to be in good condition, but were not examined at close range. The sign and marquee are considerably deteriorated, but are currently scheduled to undergo extensive restoration.

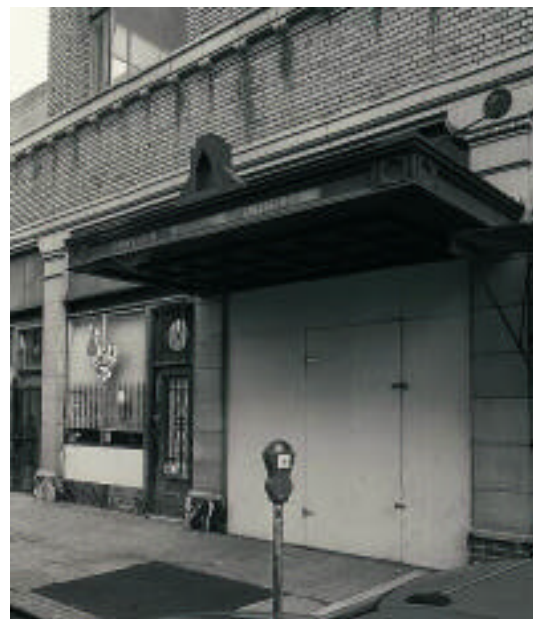
Figure 9: Entrance to Office Lobby on 19th

replaced in a few others. The original storefront glazing strips are in fairly good condition. All but a few awnings are missing, and those that remain are in only fair condition. The transom windows were not accessible during this survey, but appear to be mostly intact with the exception of several pieces of operable sash which have been altered or replaced. In general, the transom windows are in fair to good condition. The metal marquees over the office lobby entries are intact and in good condition.

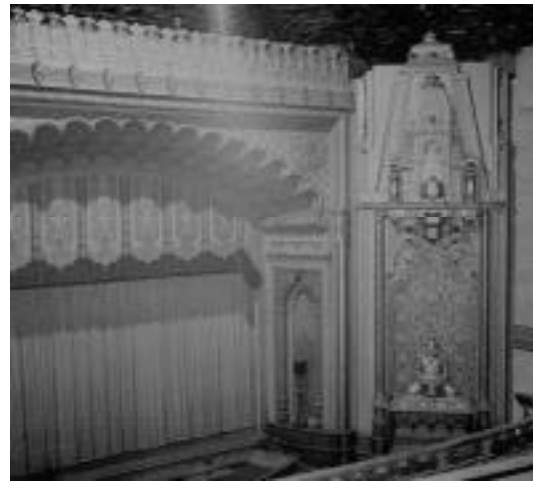
Figure 11: Proscenium and Organ Screen

The auditorium is in good condition. The plaster walls and ceiling are largely intact. Some water damage is evident in the ceiling along both side walls, but this occurs beyond the edge of the ornamental portion above the vomitories. The seats have been removed and some stored in the basement, and the stepped floor has been partially demolished. The chandeliers are missing from the main ceiling. A number of the large light fixtures are missing from below the balcony, but at least one of each type remains. The mirrors and metal screens are missing from the niches below the balcony, and the fire hose cabinets near the rear of the auditorium are missing the hose brackets, although one of the missing brackets is currently stored on the Stage.

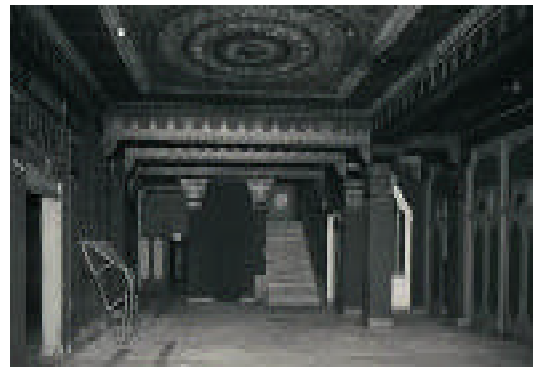
Figure 17: Main floor foyer

The Foyer is little altered from its original design. One elevator has been reoriented to serve the office wing. The doors were removed but the cast plaster frieze above remains. The check room window has been covered with a furred plaster wall and the matching niche at the opposite end has been eliminated. The drinking fountains have been removed and the tile has suffered some damage. The carpet and wood carpet strips have also been removed. The original doors into the auditorium have been replaced, but original wood panel doors still exist at the Check Room, the Women’s Toilet, and the stairs to the basement.

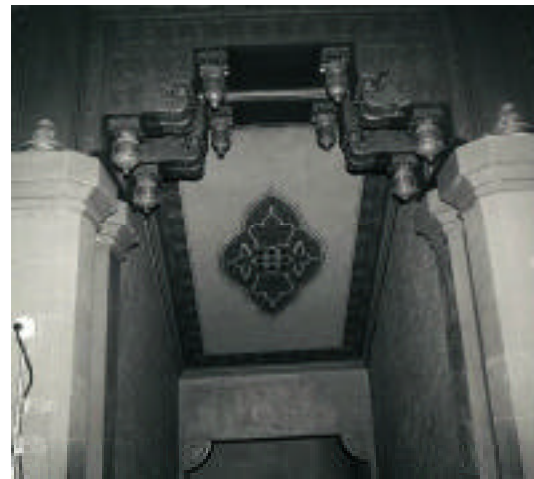
Figure 21: Stair Ceiling

The Foyer Stairs are identical symmetrical stairways beginning at each end of the main floor foyer and continuing up two flights, terminating at the Upper Vomitories. The stairs are concrete with a marble base and carpet border up to and including the second landing, and wood base from there to the top, and were originally carpeted. The walls are rough stucco plaster, and the ceilings are plaster with stenciled decoration that mimics mosaic tile or oriental carpets. The foyer entries are framed by imitation cast stone columns and cast plaster brackets. The handrails are original steel pipe rails mounted on steel brackets. Except for the missing carpeting and a small amount of damaged plaster, the stairs are intact and are in good condition.
